The Tip Stop

An Unusual P1133 DTC

Vehicle: 2008 Saturn Vue 3.6L 33,000 miles (low mileage).

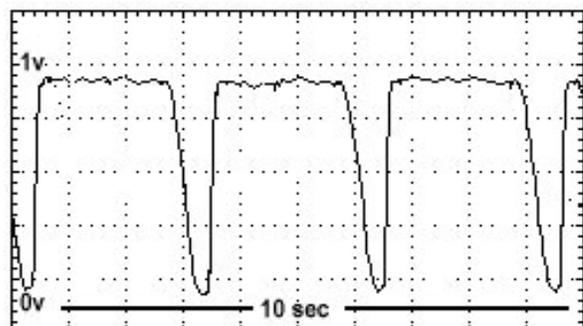
This DTC for oxygen sensor insufficient activity B1S1 typically points to a bad sensor. But in this case a sensor replacement did not fix the problem. What was unusual was the sensor voltage would go to 900mV for 2-3 secs then drop below 200mV for just a few ms then back to 900mV. It would do this at idle and when driving at cruise speeds. After two trips the P1133 code would set. B2S1 was normal. The B1S1 scope pattern looked like this:

The injectors were tested to insure none were sticking open on bank 1 causing the temporary rich mixture. The technician noticed the STFT for bank 1 would jump to +18 for 2-3 secs then to 0; it would not bounce around +/- or climb to +18. It would just read +18 all at once, then 0. Why was the ECM demanding +18 then 0? LTFT stayed +/- 5 and mostly around 0. It was apparent that the ECM was commanding the STFT change thus the reason the B1S1 was switching the way it was and setting the DTC. A check at the ECM harness connector showed the same results. Switching the rear O2 sensors did not change anything. It was as if the ECM had a command/control problem for STFT on bank 1. Could the problem be software related or internal ECM malfunction? It did not make sense that the ECM would be altering STFT in that manner. After replacement of the ECM and reprogramming, the problem persisted.

The tech then noticed something unusual about the rear O2 sensor operation when comparing bank to bank. Upon cold start B2S2 would climb to 500-600mV; but B1S2 would stay low at 100-200mV and then come up a bit after warm up. Why so much oxygen when the STFT was rich? There has to be an air leak (exhaust leak) in front of the rear O2 on bank 1. An exhaust leak was not audible under the hood.

Here is what was happening: Apparently GM's strategy to verify the O2 sensors was for the ECM to set the STFT to +18 to get a reaction from the sensors. Because the rear B1S2 O2 would not respond, it would go to +18 STFT then command it back to +0 and keep doing this all of the time the vehicle was running! The ECM would set a DTC for B1S1 activity when the front O2 was only responding as a result of the ECM commands to verify the rear O2; talk about "Fake News".

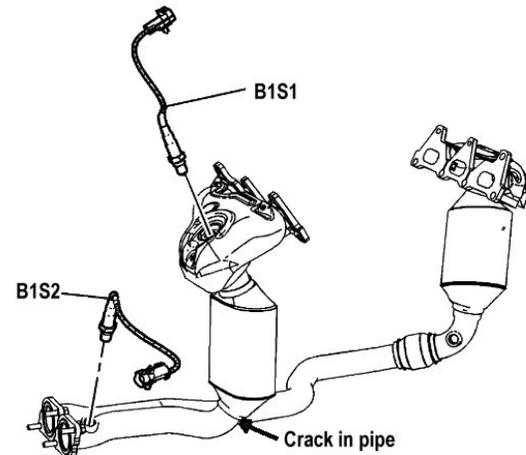
The tech raised the vehicle and found a small fracture in the pipe right at the outlet of the bank 1 converter. The crack was welded and the problem solved.

The question is why was the ECM setting a code for the front O2 when the air leak was far after the front sensor; why not a DTC for the rear O2?
